PANDIMAN PHILIPPINES Inc. P&I Correspondent in the Philippines

WARNING OF WET NICKEL ORE CARGO IN BULK FROM SURIGAO PHILIPPINES

Loading of Nickel Ore Surigao, Philippines, concerns of cargo being beyond TML

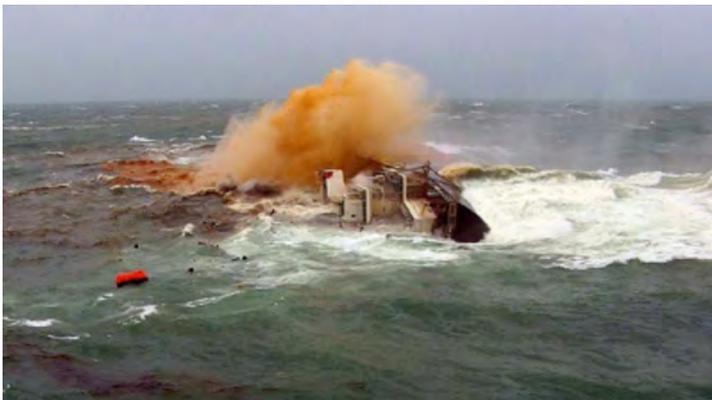
The consequences of a nickel ore cargo liquefying can be catastrophic

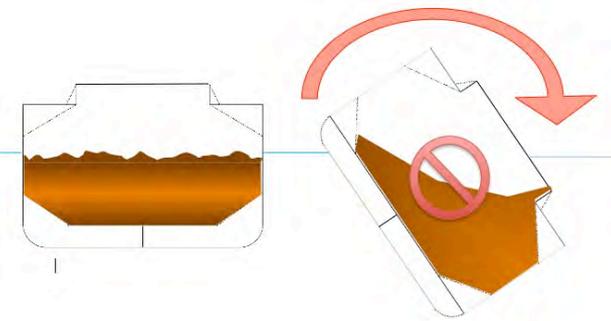
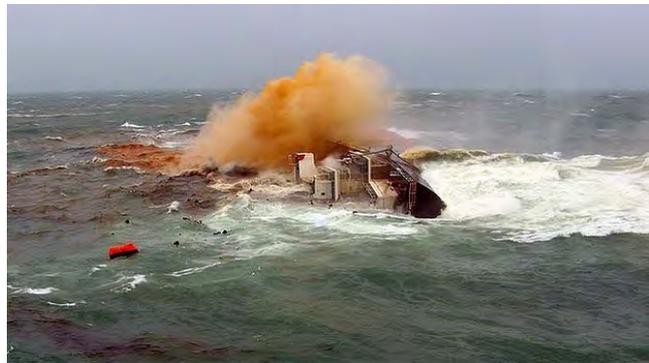
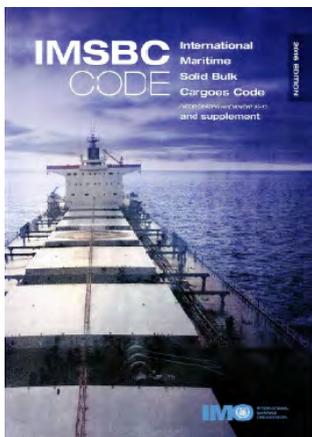
Nickel ore, when the moisture content is above the TML, (Transportable Moisture Limit) the cargo can liquefy with catastrophic results. The liquefaction of a nickel ore cargo is not like free-surface effect of a liquid but is when due to vibration and movement a solid now acts like a liquid, it is a dynamic shift. The effects of liquefaction is so dramatic that in discussions with sole survivors off two vessels we undertook search and rescue in the South China sea, the vessels rolled over and capsized in less than 30 seconds.

A picture speaks a thousand words;

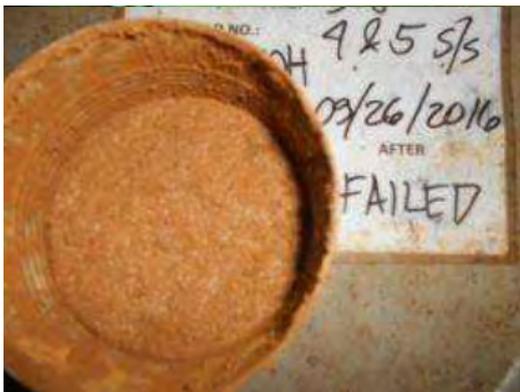
This is a simple test and as the term implies (can test) a metal can is suitable, such as a coffee tin, paint tin (but must be clean). Take about 1 to 2 kg of the ore and place it in the tin, repeatedly slam the can the bulk code says 25 times, **if the ore remains the same** then there are no obvious signs of moisture, if it shows any signs of liquefying (very obvious will be where free water appears on top **or takes on a shiny flat appearance**) then the cargo should be **rejected and not loaded**.

A failed test – flat pancake appearance- - FAIL carry out laboratory analysis of cargo

A can test **should never be used as a basis alone to determine if a cargo is safe to load**, a can-test is a rudimentary field test to try and observe if there is obvious signs of moisture, it is not a method for loading a vessel. The only way to determine a cargo meets the IMSBC is through a laboratory analysis. Even cargo that can show no obvious signs of moisture in a can test will still fail an analysis when observed to Plasticise (see below) or Splatter, as for this to occur the cargo is already beyond its FMP. Can tests have become even more unreliable in the Surigao area because of the high clay content of the nickel ore.

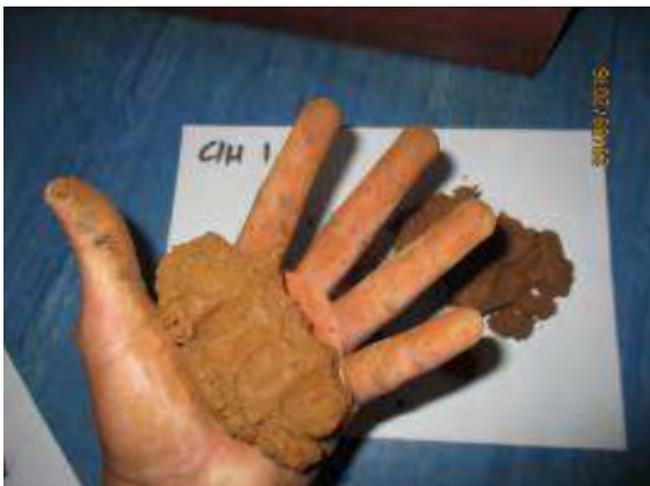
This is when a sample of cargo is placed in the hand, the sample is compressed, if on opening the hand the sample retains its shape this is evidence of High moisture – FAIL carry out laboratory analysis of cargo

When a sample can be molded and retains a shape we say it has “Plasticised”, to have the ability to do this then moisture must be present.

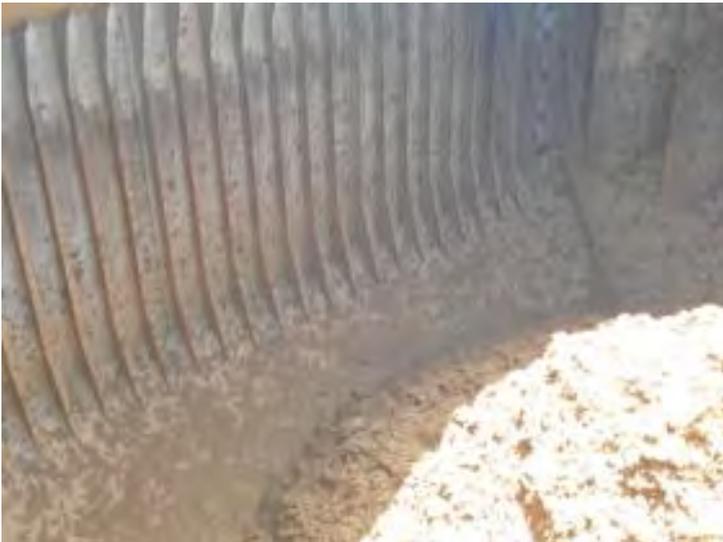
Any sign of splatter in the hold, large or small this indicates high moisture – FAIL - carry out laboratory analysis of cargo
